OHIO RIVER BASIN  
CHERRY RUN, INDIANA COUNTY  
PENNSYLVANIA  
CHERRY RUN DAM

6 PHASE I INSPECTION REPORT  
NATIONAL DAM INSPECTION PROGRAM.

10 Bernard M. Mihalcin  
PREPARED BY

11 AUGUST 1979

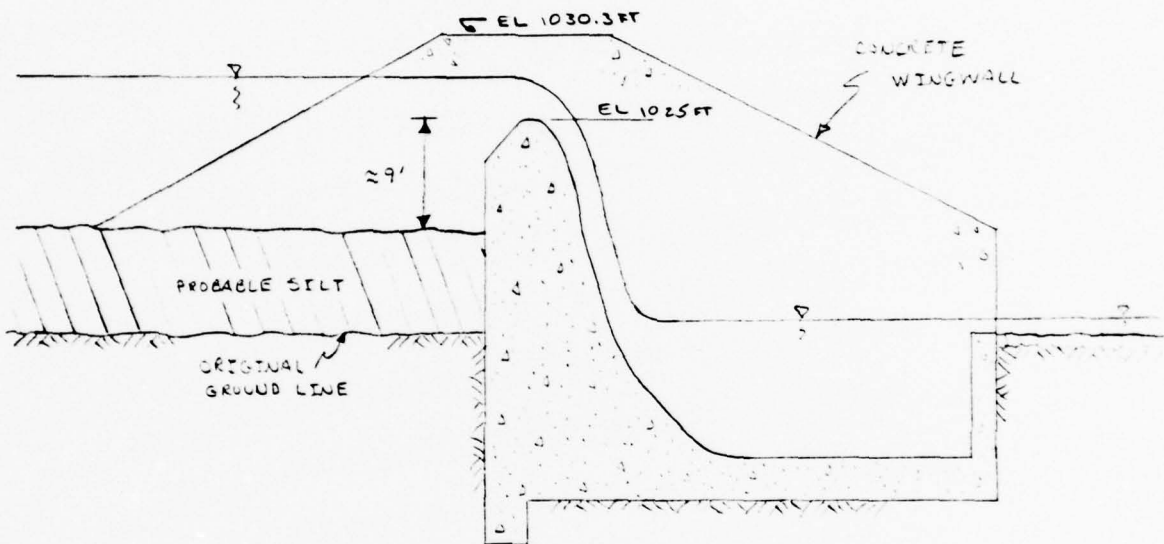
- PROFILE OF SPILLWAY : (NOT TO SCALE)  
(FROM FIELD MEASUREMENTS AND OBSERVATION, AND FIG 3)

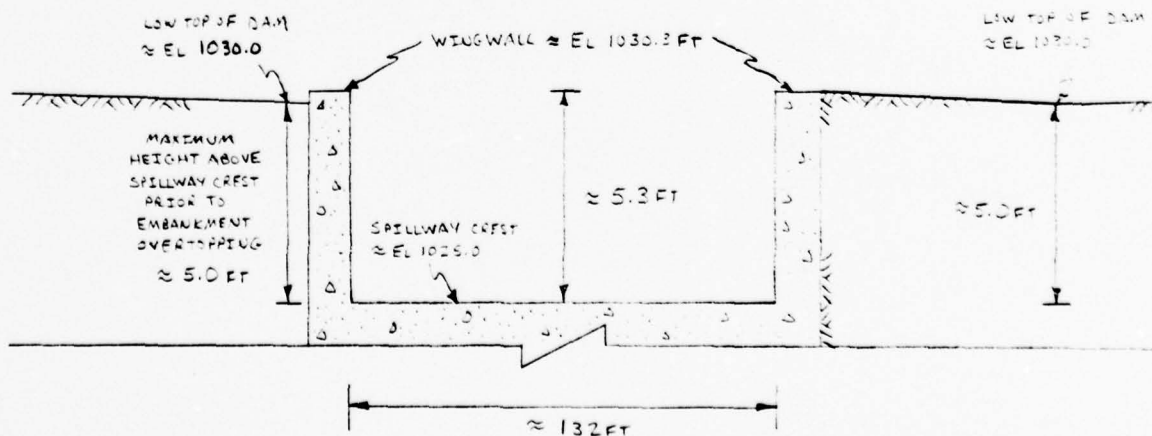
- CROSS-SECTION OF SPILLWAY : (NOT TO SCALE)  
(FROM FIELD MEASUREMENTS AND OBSERVATIONS, AND FIG 3 AND 4)

SECTION TAKEN LOOKING UPSTREAM TOWARD SPILLWAY

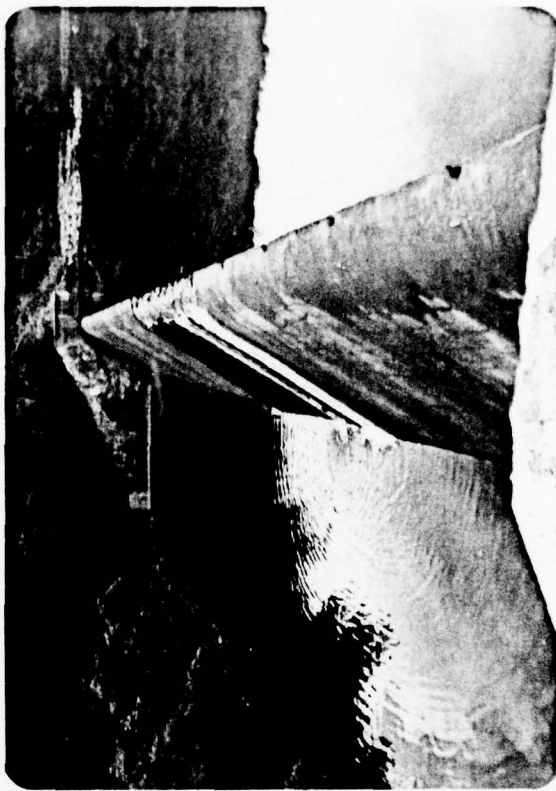
1. Spillway. The spillway is considered to be in poor condition suffering from general concrete deterioration. The overflow weir (reportedly gunnited in the early 1950's) is extensively cracked and has begun delaminating (peeling) near its center (see Photographs 8 and 9). The wingwalls are extensively spalled, cracked and noticeably misaligned (see Photographs 9 and 10). The downstream channel is overgrown with shrubs and trees which could restrict flow and cause high tailwater conditions.
